**THE CALIFORNIA EARTHQUAKE OF APRIL 18, 1906**

**REPORT**

**STATE EARTHQUAKE INVESTIGATION COMMISSION**

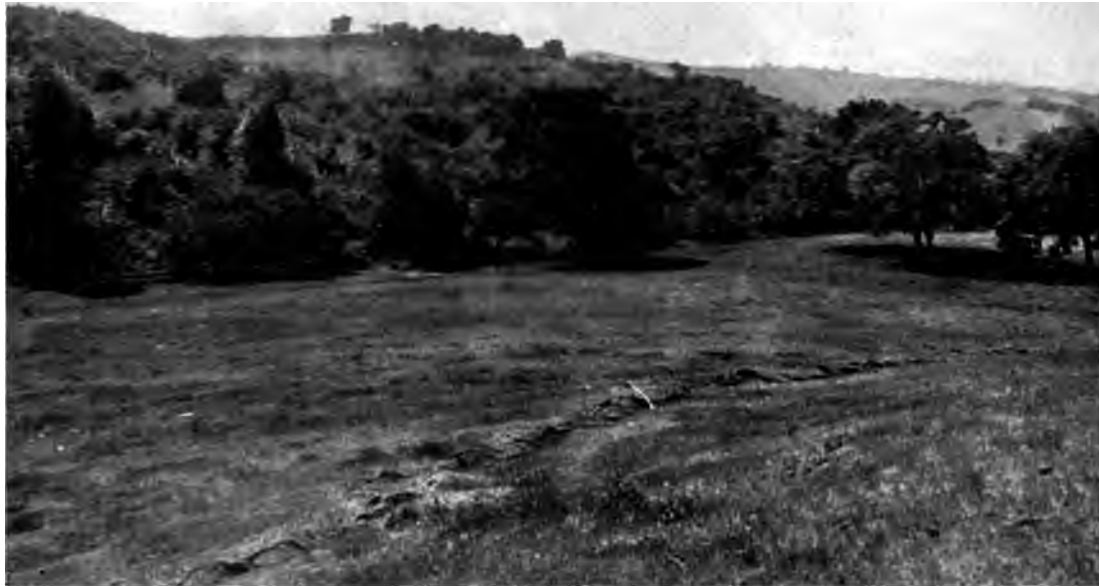
B. The Rift valley 5 miles west of Stanford University. Fault-trace in foreground. Per J. O. B.

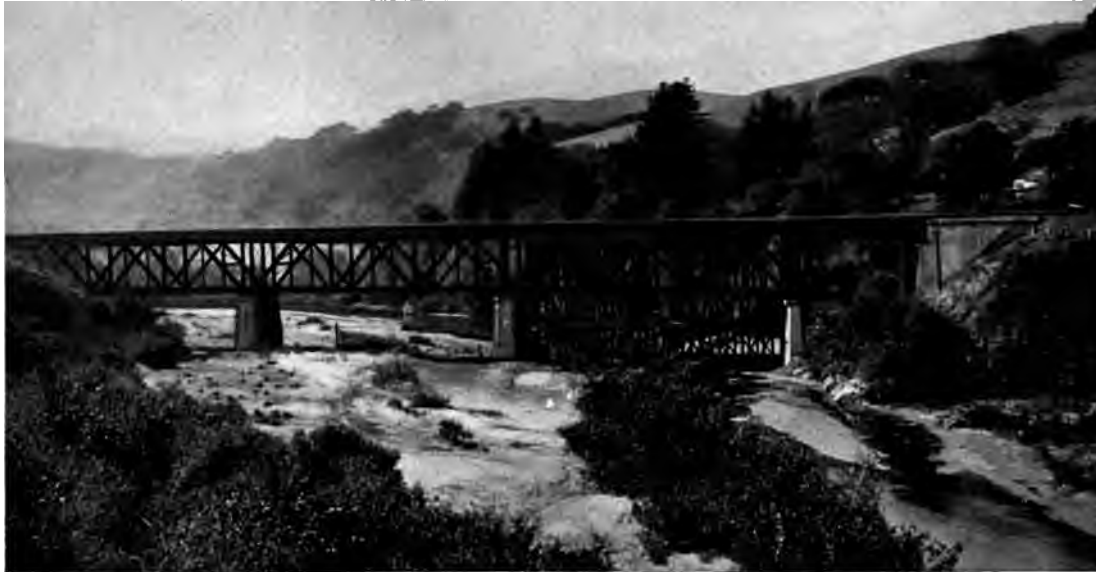
The earthquake of April 18, 1906, opened and displaced the walls of the old fault along the Rift as far south as the town of San Juan in San Benito County. The fault-trace passes directly under the western span of the Southern Pacific Railroad bridge across San Juan River, as shown by the displacement of the piers at the end of the bridge, a distance of 3.5 feet. For a distance of nearly half a mile on either side of the bridge, the river has established itself in the Rift. To the northwest the steep slopes of Mount Pajaro facing the canyon do not show any regular fissure. This does not, however, indicate any discontinuity in the fault, for the surface of the whole mountain is more or less broken by auxiliary cracks, secondary fissures, and slides.

A. The Rift followed by the Pajaro River at Chittenden. Dislocated bridge supported by false work. H. W. F.

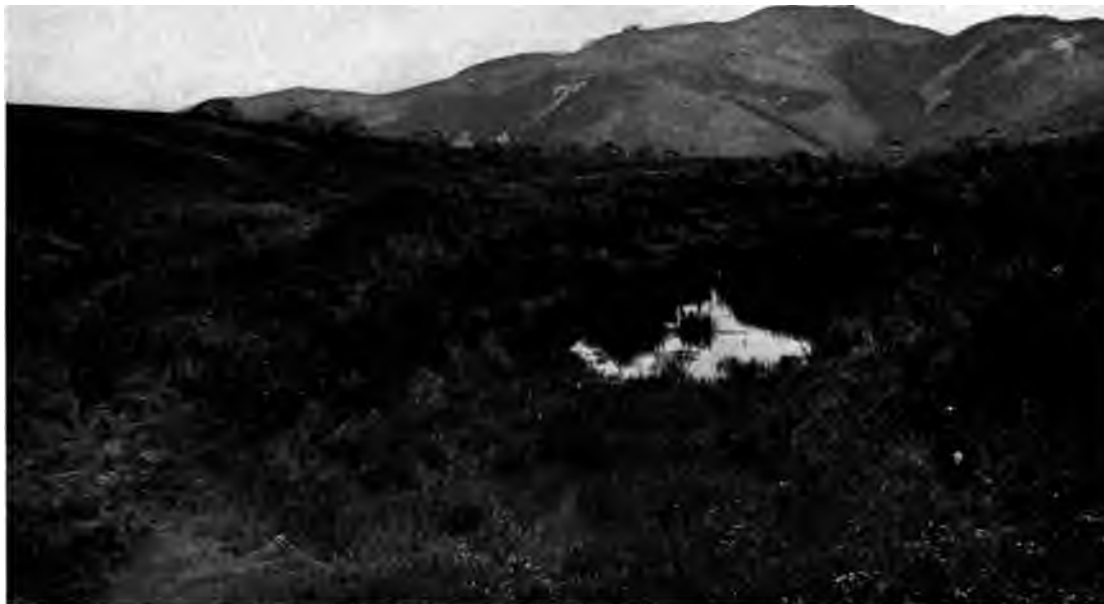
Southeast over the hills from the point where the Rift leaves the river, the characteristic features of the Rift make their appearance. It is marked by a small pond (plate 17B), springs, and a more or less continuous ridge with its steeper face toward the southwest. The fissure of the recent earthquake follows this series of features (plate 18A), and, at a point halfway between the bridge and San Juan, there is shown in a broken fence a horizontal displacement of 4 feet. A mile before reaching San Juan, granitic rocks are exposed upon the southwest side of the Rift. Shortly beyond this point the Rift leaves the hills and traverses the western edge of the valley of the San Benito River. The ridge which we have been following is now lost in the level floor of the valley, but as far as traceable its course is directly toward the low bluff upon the eastern edge of the town of San Juan. The fissure of the recent earthquake is to be seen where it crosses the road 0.5 mile northwest of San Juan, but has not been noted farther along the old Rift line. It appears to bend more easterly, and this probably connects it with the disturbances of the earth between Hollister and San Juan. Mr. Abbe, of San Juan, states that the earthquake of 1890 opened the old Rift and that the displacement of the walls, tho small, was in the same direction as in the recent earthquake.

B. The Rift a mile southeast of Chittenden. Pond on upper slope of hill. H. W. F.

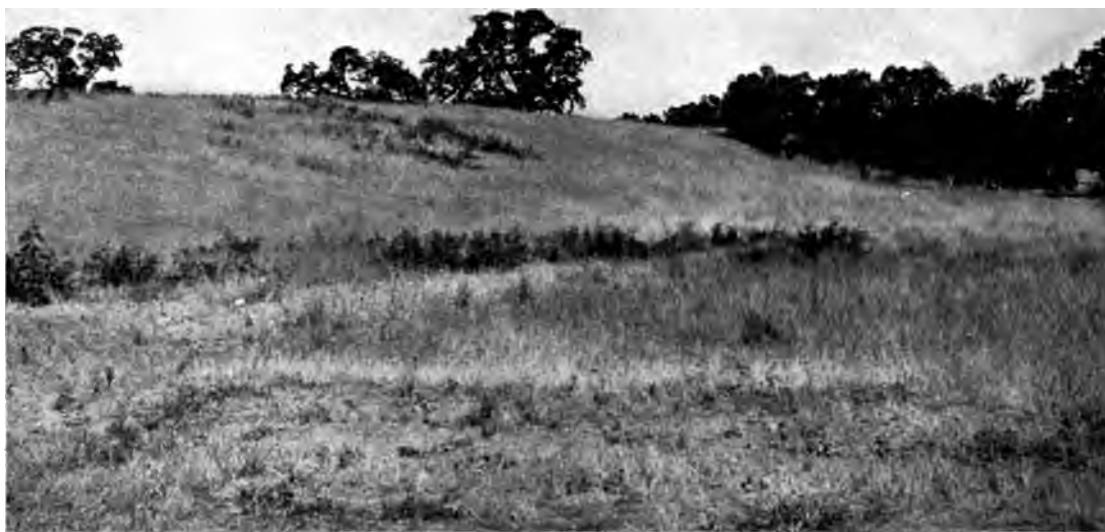
The Rift can be traced thru the hills at the head of the Cholame Valley by its characteristic features, as well as by bluffs which are undergoing rapid erosion. It crosses the road a mile west of Parkfield and exhibits here a regularly rounded ridge 200 feet wide and 20 feet high at the most elevated point. (Plate 19B.) That the ridge must be hundreds of years old is shown by the great oak trees that are growing upon it. One white oak is fully 8 feet thru. Large springs mark the fissure at this point, and are found along it the whole length of the Cholame Valley. According to a resident, the Rift opened along the ridge in the earthquake of 1901, the opening being distinctly traceable for several miles. Southeasterly from the point just described thru the Cholame Valley, there appears no very prominent ridge or escarpment, altho springs and cienegas, marking a gentle swell in the flat open surface of the valley, indicate the line of the Rift.

B. Ancient scarp on the line of the Rift a mile west of Parkfield, Cholame Valley. H. W. F.

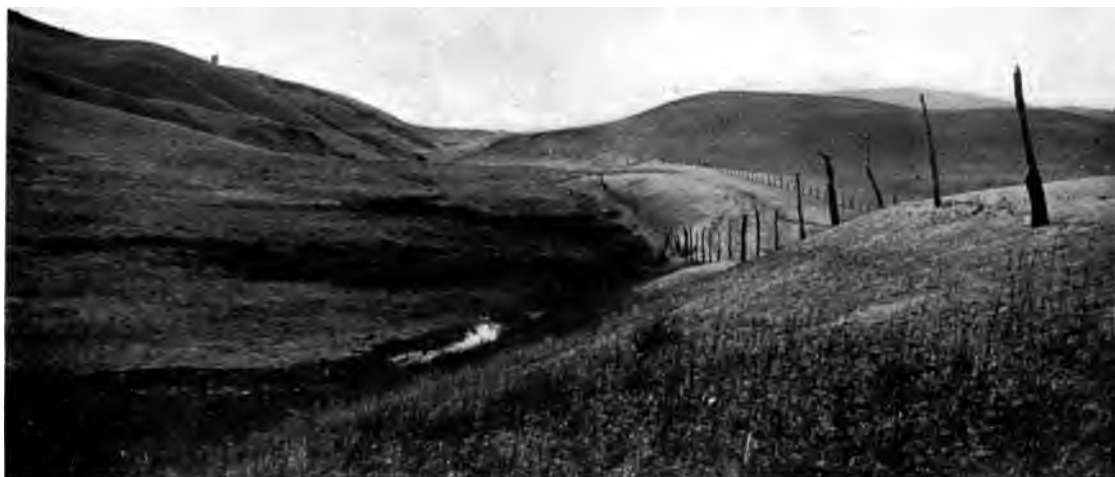
B. Looking east along the Rift from Gorman Station. The low scarp was probably made in 1857. H. W. F.

(See plate 22B.) The fissure follows its northern side for several miles and then, bending a little toward the south, crosses the canyon and takes a course for Tejon Pass. The granitic mountains upon the north of the canyon rise with exceedingly steep slopes, the rocks of which have been thoroly shattered. Immense quantities of rock débris have been brought down the gulches, building up in the main canyon a succession of large and steep débris fans. So much débris has been carried down the canyon that it has been blocked at the point where it turns toward old Fort Tejon, and has thus given rise to Castac Lake. The Rift crosses the divide at the gap known as Tejon Pass. Here there are features due to two movements. Descending a few hundred feet, we find ourselves in a long valley, extending about 10 miles in a direction a little south of east. Springs, marshes, and two ponds mark the line of the Rift from Gorman Station easterly. (Plates 23B and 24A.)

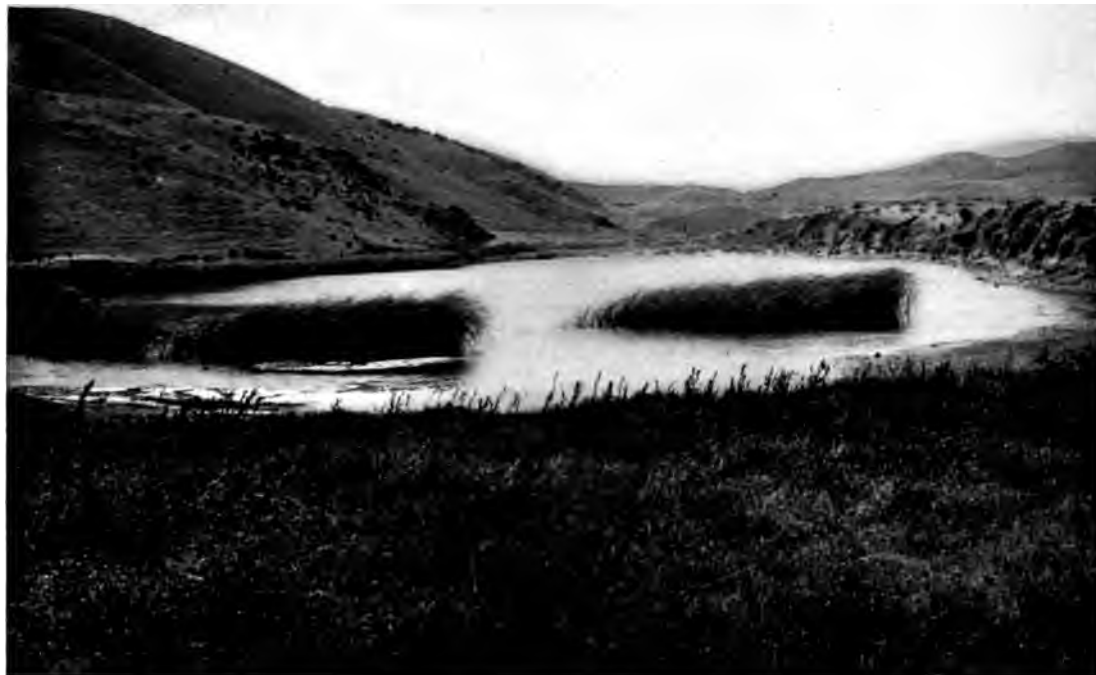
A. Pond and scarp in Rift east of Gorman Station. H. W. F.

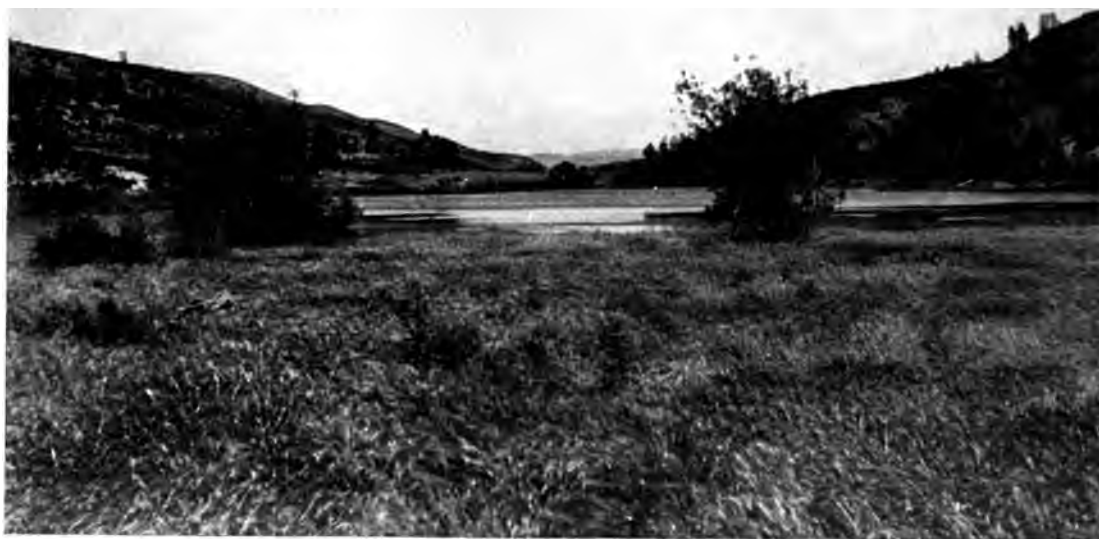
B. Lower Lake Elisabeth. In the Rift. H. W. F.

Lake Elizabeth and Lower Lake (plate 24B) are both due to the blocking of the drainage of two valleys extending along the Rift. These valleys lie on the slope of the range toward the desert (Antelope Valley), but their outlet is southward by a narrow canyon thru the heart of the mountains lying between the desert and Santa Clara River. A low escarpment along the southern side of the valley in which Lake Elizabeth lies, and eastward, is replaced by a lofty rounded ridge which appears to be due to some one of the movements along the old fault. For several miles east of the lake (plate 25A) the distinctive and characteristic features of the Rift are not as easily made out, altho the ridge just mentioned is full of springs and exhibits a widespread landslide topography. Toward the eastern end of this ridge small hollows and a low, indistinct escarpment again appear. The ridge separates Leones Valley, a fertile and well-watered district 5 or 6 miles long, from the open Mojave desert on the north.

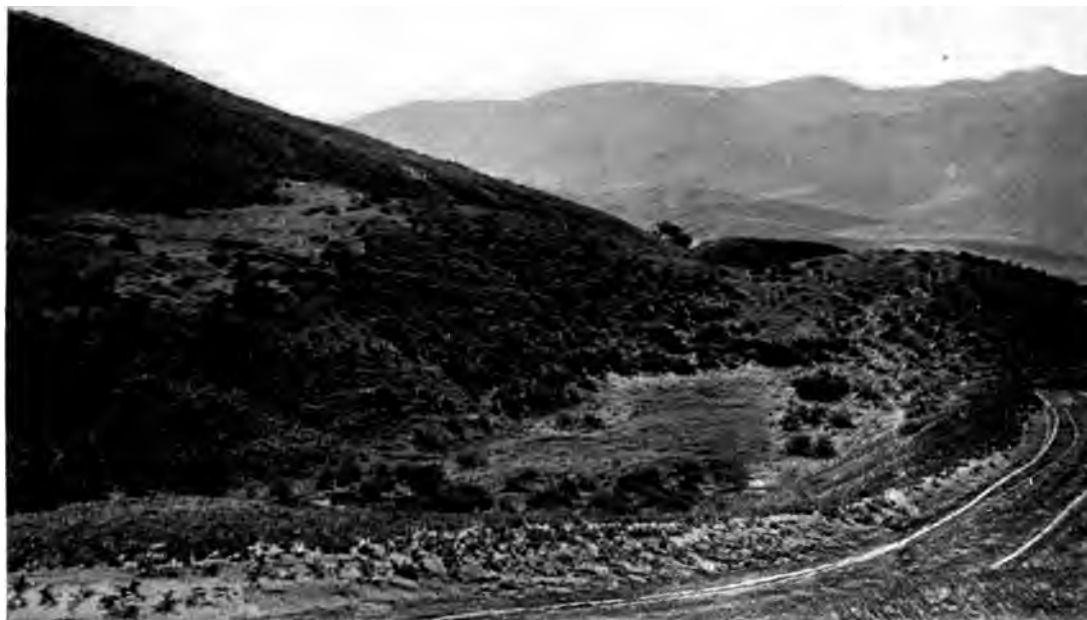
A. Looking west along the Rift from Cajon Pass, showing double scarp. H. W. F.

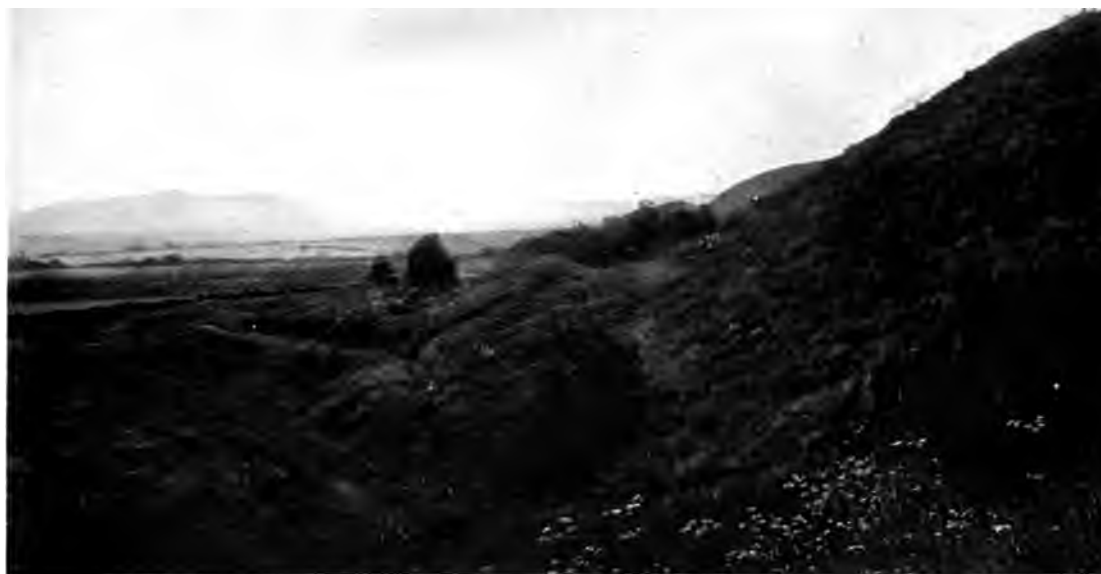
B. Double fault-scarp in Rift north of Highland, at base of San Bernardino Range. H. W. F.

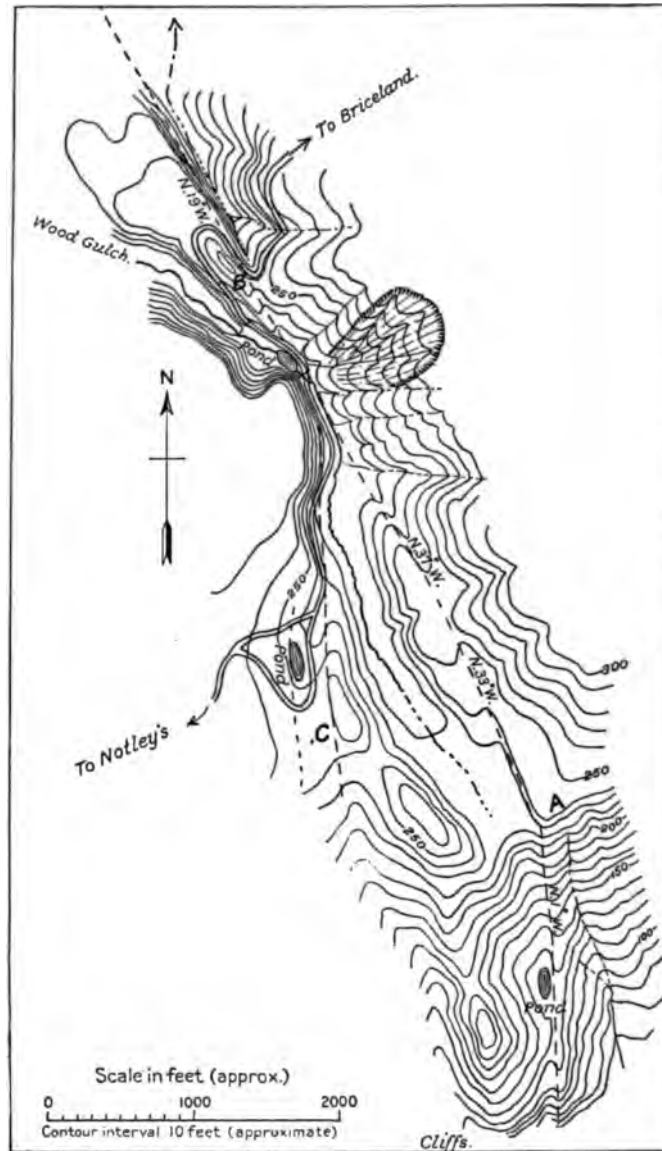
FIG. 10.—Map of country traversed by fault to north of Shelter Cove, Humboldt County.

On the beach of Shelter Cove, 100 yards west of the frame hut of Snider (at the mouth of Deadman Gulch), the fault passes thru the bluffs obscured by dislocated masses of dark conglomerates. From the top of the escarpment, however, it is easily traced for some distance down. The approximate contour map of the fault (fig. 10) sufficiently describes the topography here. A notable feature is a small elongated pond on the steep hillside, walled in by a small ridge. Thru this the fault-trace passes longitudinally. Continuing north, the line remains east of the upper valley of Wood Gulch until it joins the wagon road in the bottom. The line is by no means straight, as the bearings on the map indicate. A pronounced angle in its course exists at *A* (fig. 10), and the coincidence in this change of azimuth with the abrupt topographic change at this point is strongly suggestive of a hade to the west. Near the loop in the road at *B* the fault is easily recognized, except where the road has been repaired. The fault-trace here passes thru a

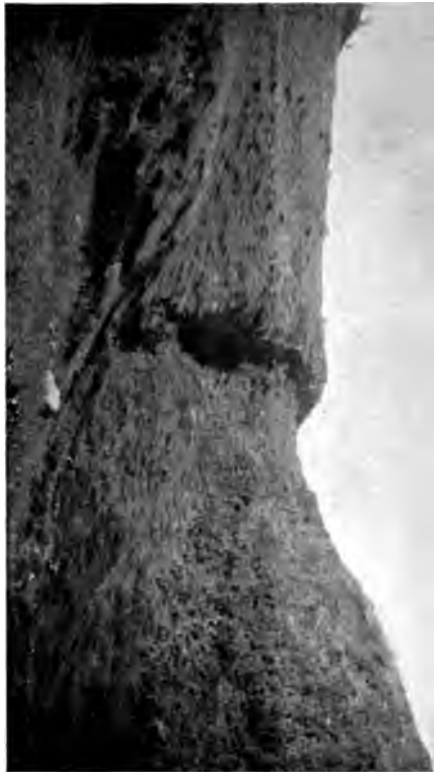
characteristic little gap or saddle (plate 31A), and south of *B* follows closely an old fault line, with a slight upthrow on the west. North of the road the fault-trace follows a ravine for some distance, then passes along the west side of a low ridge, as indicated in the contouring, and finally drops down to Humboldt Creek. Thence it ascends the

A. Fault-scarp passing thru saddle at head of Wood Gulch, looking south-southeast.  
F. E. M.

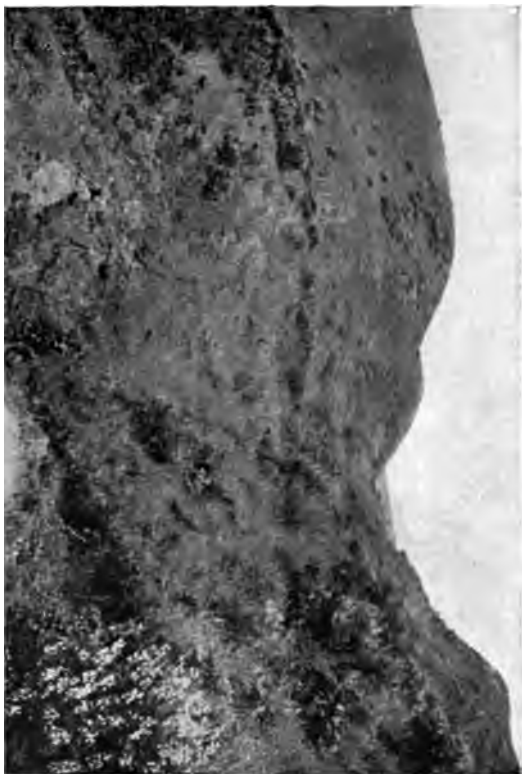
B. Auxiliary fault-trace following old scarp in saddle between Wood Gulch and  
Humboldt Creek. F. E. M.

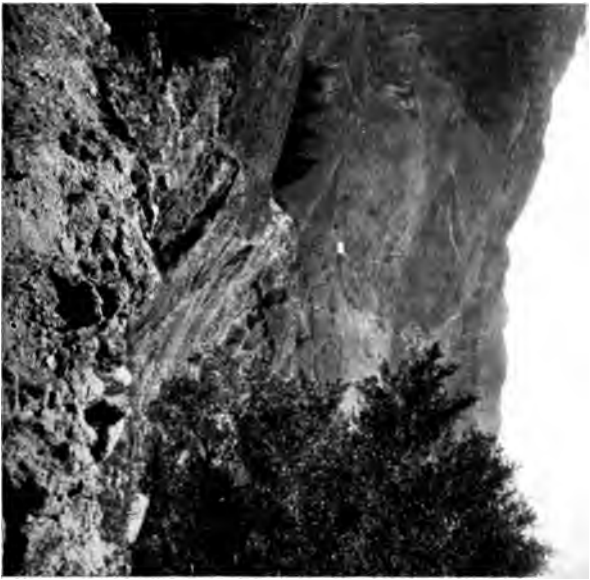
south slope of Telegraph Hill, following for a considerable distance a characteristic fault feature on the steep brushy spurs indicated in plate 31D. Immediately south of the summit of Telegraph Hill the disturbance is the most pronounced, being accompanied apparently by an upthrow on the west side, resulting in a sharp-crested ridge some 4 feet high. It is possible, however, that this ridge is not the result of the recent disturbance, but of a former one, modified into a more acute form by the shaking off of the sod. (See plate 31C.) From the summit of Telegraph Hill a bearing was taken over the entire length of the line down to Shelter Cove: N. 25° W. Projecting the line north from the hill on the azimuth, it appears to head for a number of high mountains of the King's Peak Range, altho no visible traces of the disturbance are found north of Telegraph Hill. Immediately north of its crest is the upper end of a great hopper-like landslide, clean swept for over a thousand feet. The fault-trace is entirely obliterated by this slide. The exact location of the fault north of Telegraph Hill was not ascertained. Under the

C. Looking south-southeast from Telegraph Hill along fault-trace marked  
by sharp-crested ridge in foreground, with upthrust of 4 ± feet. F. E. M.

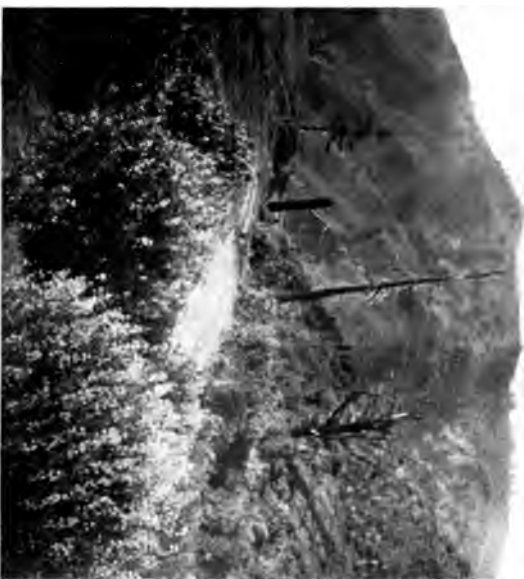
D. Looking north-northwest along main fault marked by small ridges  
on spurs of Telegraph Hill. F. E. M.

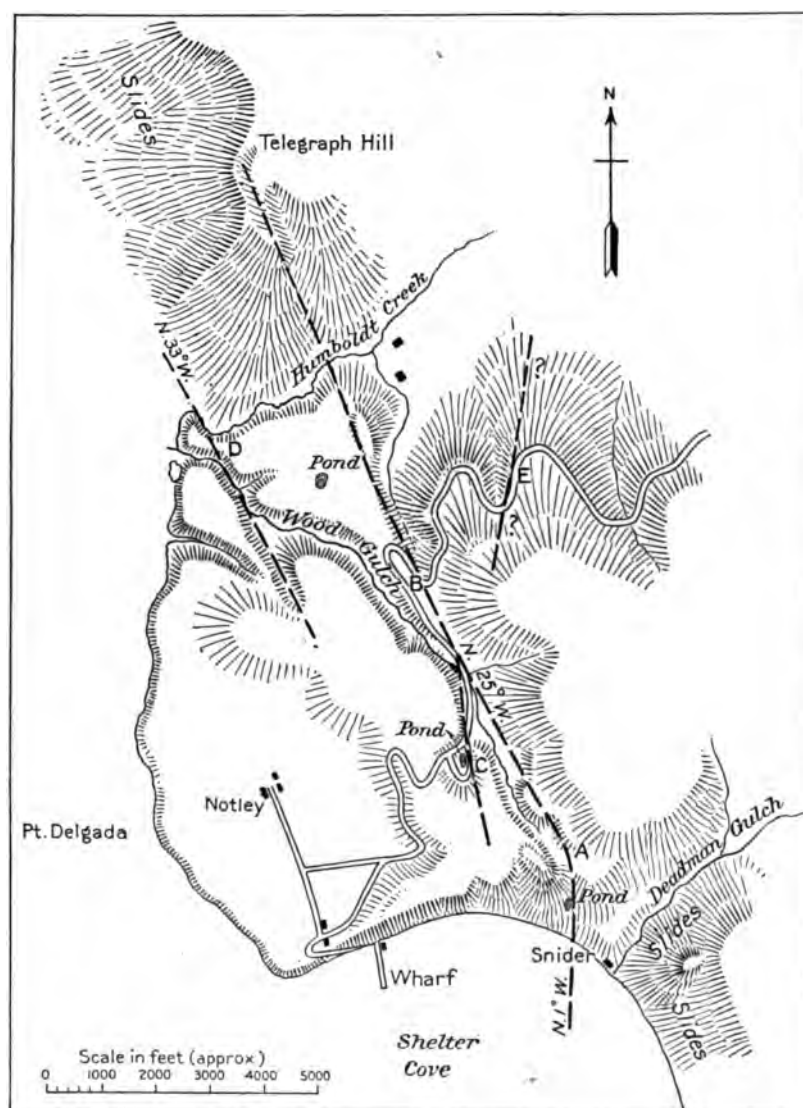
auxiliary fault cracks accompanying the main fault-trace in Sonoma and Mendocino Counties, which it greatly resembles in surface characteristics. Another line of some prominence was discovered near the mouths of Humboldt Creek and Wood Gulch. As fig. 11 indicates, this fault-trace, *D*, follows for some distance along Wood Gulch, then crosses over to the little gorge of Humboldt Creek (plate 31B), which it follows out to its mouth. The divide at *D* has a marked depression along the line of faulting. The fence cross-

FIG. 11.—Map of country north of Shelter Cove, Humboldt County, showing auxiliary faults in relation to main fault.

ing it shows no signs of horizontal shifting. It was not learned whether or not it has been repaired since the quake. Tracing it to the south up over the grassy hills, it is found to disappear somewhere near the head of the little gulch shown on the map. A third line was found along the wagon road at *E*, following an old fault ridge descending the hillside on a slant. Its probable connection with the *C* line suggests itself.

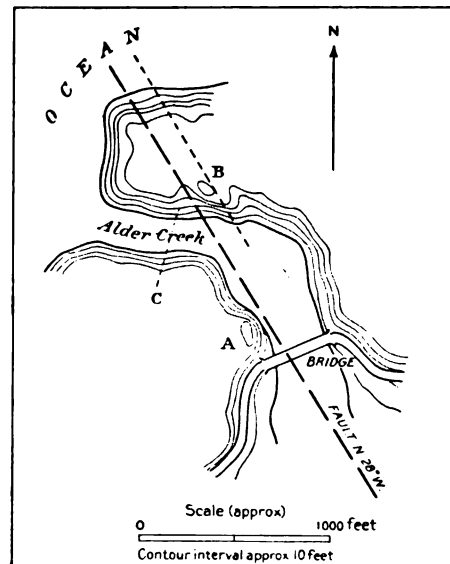
FIG. 12. — Map of mouth of Alder Creek, showing position of fault-trace.

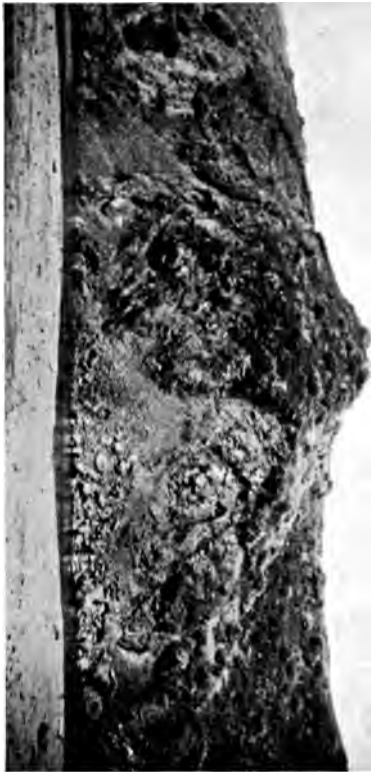
A. Rocky stream cliff 60 feet high on north side of Alder Creek. Fault vertical on left of knoll; auxiliary fault on right of knoll. F. E. M.

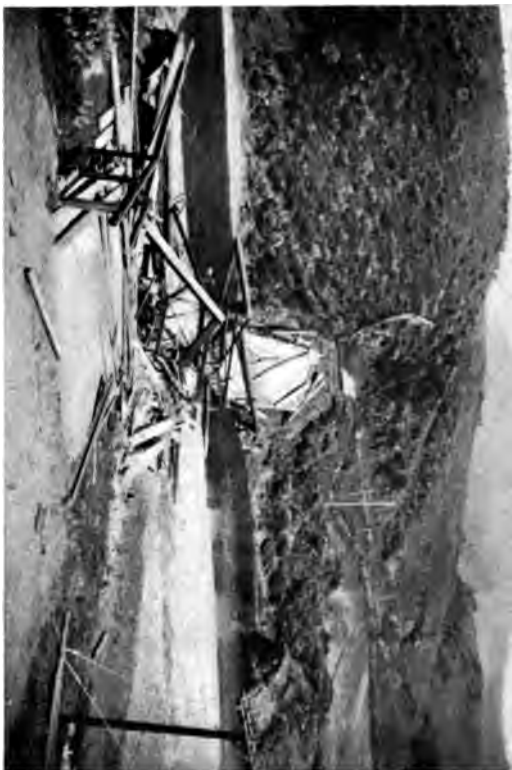
Southeast of this point, the fault-trace follows the broad stream bed of Alder Creek for nearly a mile, passing beneath a bridge, the wreck of which is shown in plate 32B. In this view, the horizontal offset of the bridge along the fault-line is well shown. It is apparent that this offset is not less than the width of the bridge. On the southwest side of the stream, near the bridge (A, fig. 12), the fault-trace is flanked by peculiar, isolated, rocky knobs similar to that on the northeast side. It is not clear, however, that these rocky knobs have more than an accidental relation to the fault, since they may possibly be residual sea-stacks upon the uplifted wave-cut terrace.

B. Fault passing under bridge over Alder Creek. Bridge displaced not less than its width. F. E. M.

The wagon bridge over Alder Creek (plate 32B), which stood astride of the fault, is a complete wreck. The timbers broke in many places, and the tension rods were twisted and in some cases actually ruptured.

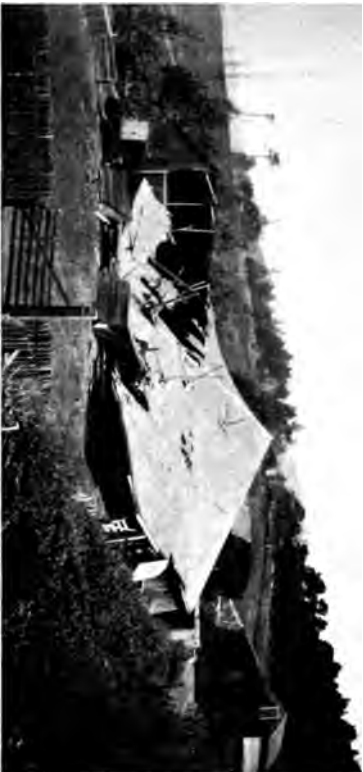
C. Barn of E. E. Fitch, north of Manchester. Astride the fault. F. E. M.

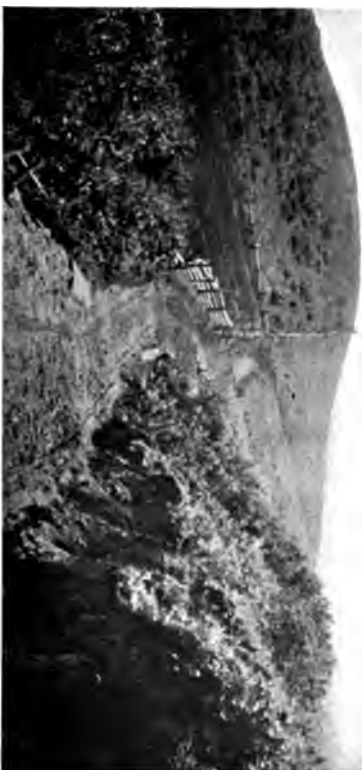
the zone of dislocation being in low, marshy ground. At another place near Manchester, where an east and west fence follows the north side of a wagon road, both fence and road have been offset as shown in plate 32d. In both cases the relative movement on the southwest side was to the northwest. The dairy barn on the ranch of Mr. E. E. Fitch stood astride the line of movement and was demolished by the torsion to which it was subjected. The wreck of the barn is shown in plate 32c. At two places along the stretch between Alder and Brush Creeks the bearing of the fault-trace was measured, the readings being N. 28° W. and N. 30° W.

D. East-west fence 0.25 mile north of Manchester offset by fault. Fence and road were formerly straight and have been repaired. Looking east. F. E. M.

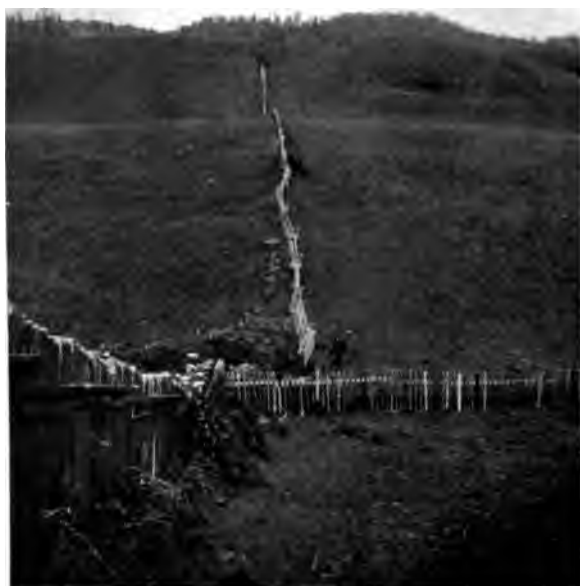
A. East-west fence near saddle between Garcia River and Brush Creek. Main offset 13 feet. Auxiliary offset 2.5 feet in middle ground. F. E. M.

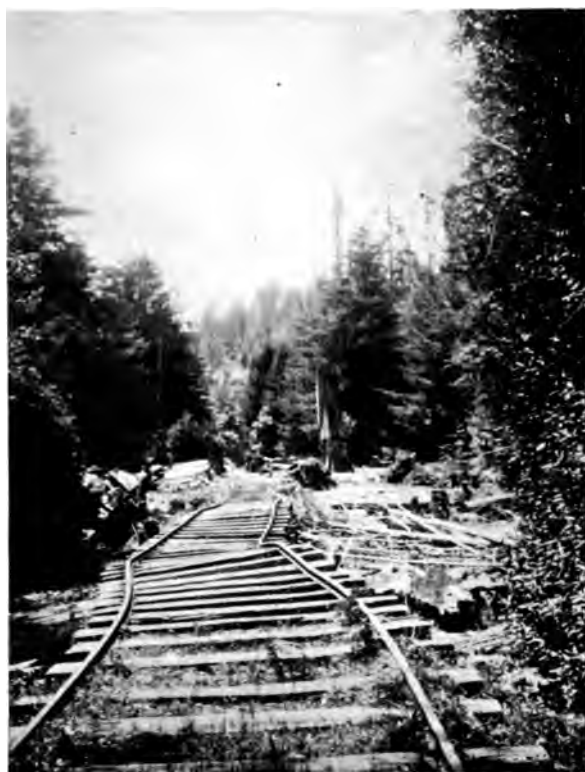
B. Small railway trestle, Little North Fork Gualala River, looking north. Main fault-trace 100 feet to right. Auxiliary crack under trestle. F. E. M.

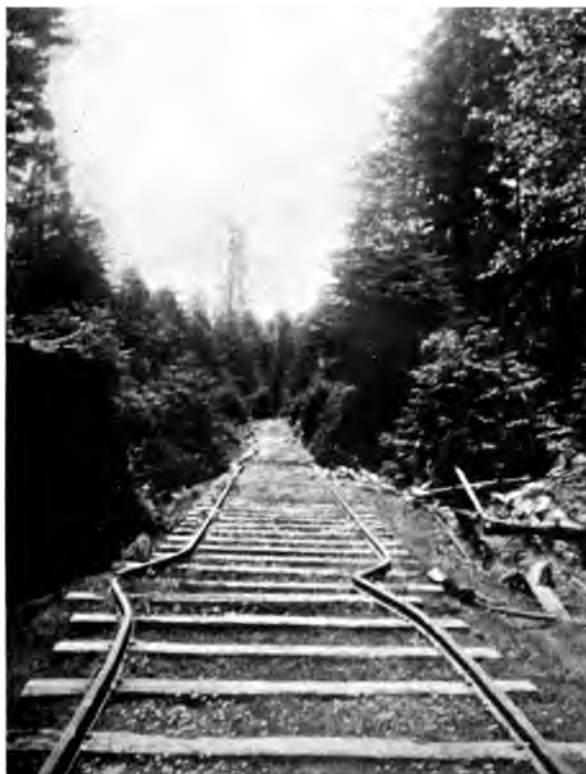
C. Buckled track, Little North Fork Gualala River. Both rails broken. Fault-trace parallels track 50 feet to left. F. E. M.

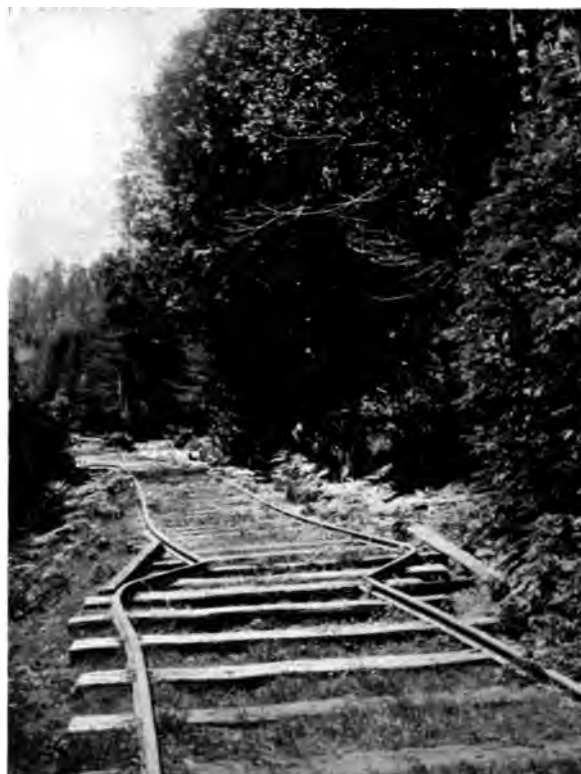
D. Buckled track, Little North Fork Gualala River. Fault-trace 100 feet to left. F. E. M.

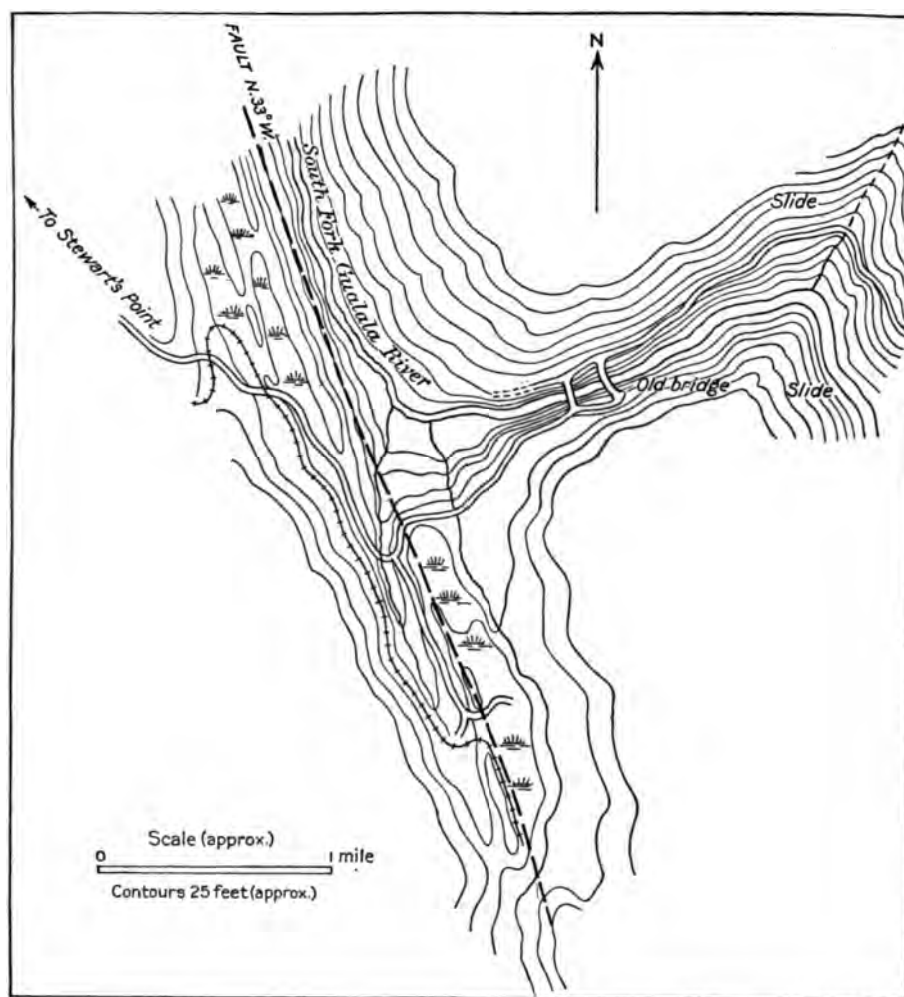
a point east of Stewart's Point. Here the line runs on the lower side of a double series of low ridges, interspaced with elongated swamps, and all trending parallel with the river. (See fig. 13.) Its bearing is N. 33° W., altho only short sights could be obtained on account of the timber and brush. The bearing noted is nearly in line with the axis of the valley of the South Fork of Gualala River. The amount of dislocation could be estimated only in a rough way from the offsets in the road leading east from Stewart's Point to Lancaster's ranch. A few neglected picket fences gave doubtful results, the alinement of the pickets having been previously disturbed by forest fires, fallen trees, etc. The horizontal movement is distributed over two strong, and one or more dim, lines of

FIG. 13. — Map of valley of South Fork of Gualala River, showing relation of fault-trace to geomorphic features.

faulting, all of them producing offsets ranging from a few inches to several feet. The total displacement apparently did not reach 8 feet. As will be apparent from fig. 13, a logging road runs southeast parallel with the fault for 0.75 mile, and then crosses the same at an abrupt turn. It so happens that the road at this point has been cut thru one of the narrow ridges referred to, the depth of the cut being about 7 feet. The movement on the fault has practically closed the cut, so that it is now barely passable on foot. The bridge over the South Fork of the Gualala River, 3 miles east of Stewart's Point, had

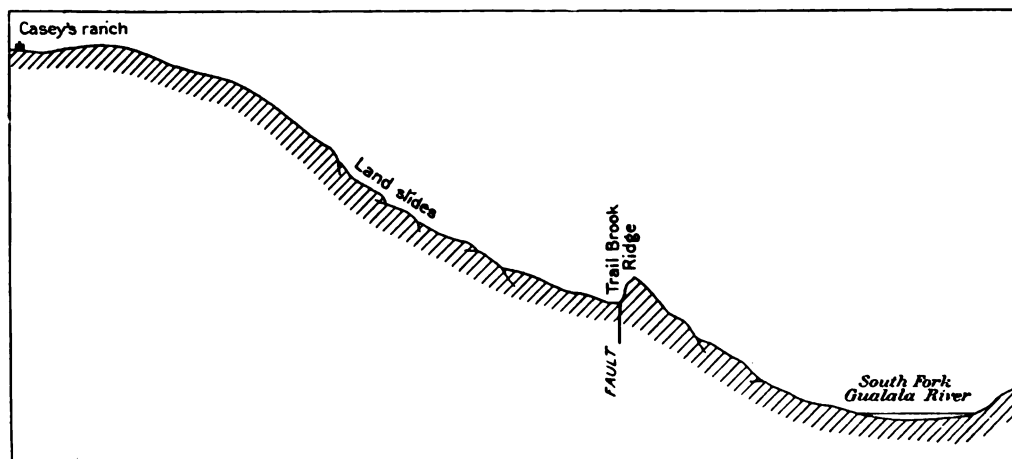
FIG. 14.—Profile of southwest side of South Fork of Gualala River, showing relation of fault to geomorphic features.

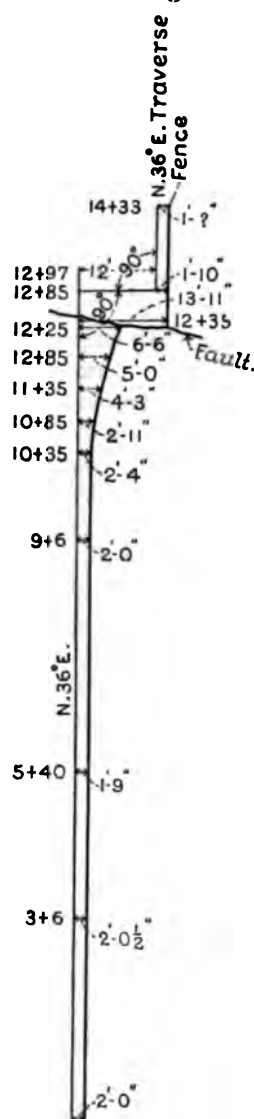
FIG. 15.—Offset of fence by fault at Fort Ross, showing distribution of the deformation on southwest side of fault. Scales: Along fence, 1 inch = 200 feet. Normal to fence, 1 inch = 20 feet.

results of his survey are shown in fig. 15. The bearing of the fence is N. 36° E. He reports that for the first 1,000 feet from the southwest end of the fence the greatest error in alinement was about 1 inch, and that practically there was no deformation in this stretch. In the next 125 feet going northeast there was found a deviation from this alinement of 4 inches to the southeast. In the next 50 feet the deviation in the same direction was 7 inches more. In the next 140 feet the deviation in the same direction was 3 feet 7 inches more. Then came the fault-trace with an abrupt displacement of the fence of 7 feet 5.1 inches. Northeast of the fault-trace the fence retained its line very well. In 100 feet it was out only 1 inch. Beyond this it enters the timber and its course is somewhat influenced by the larger trees, but maintains its line within a few inches. These measurements give a total horizontal displacement of 12 feet distrib-

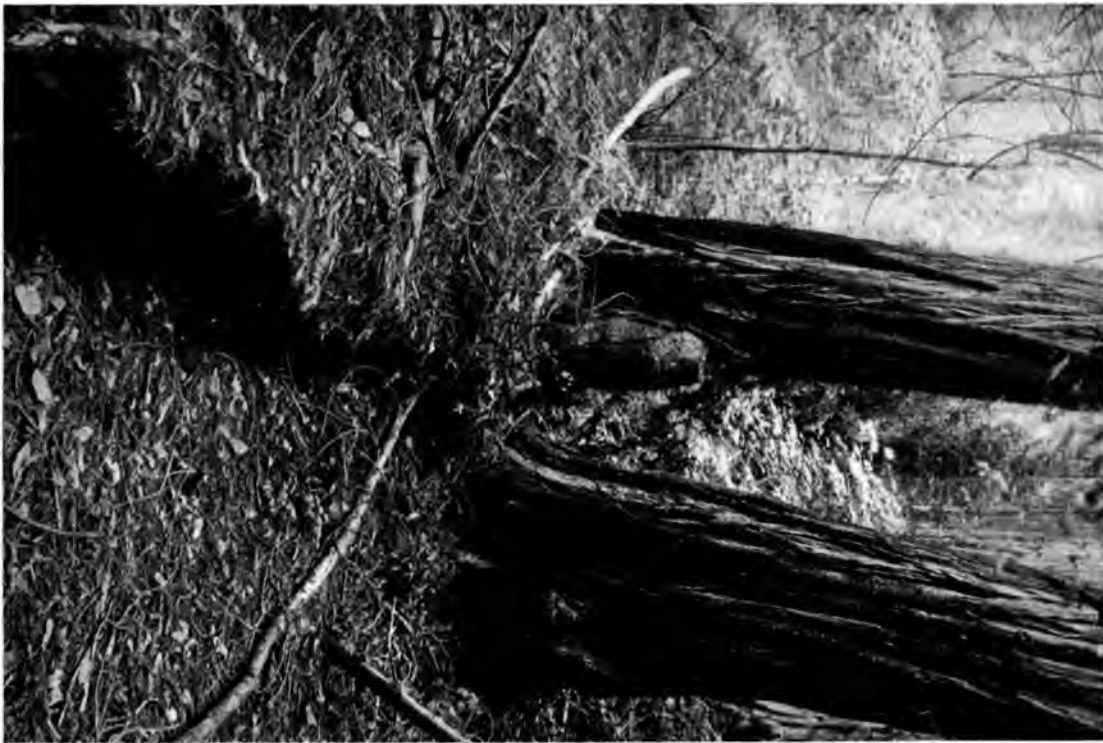
A. Fault-trace in redwood forest near Fort Ross. J. N. I.

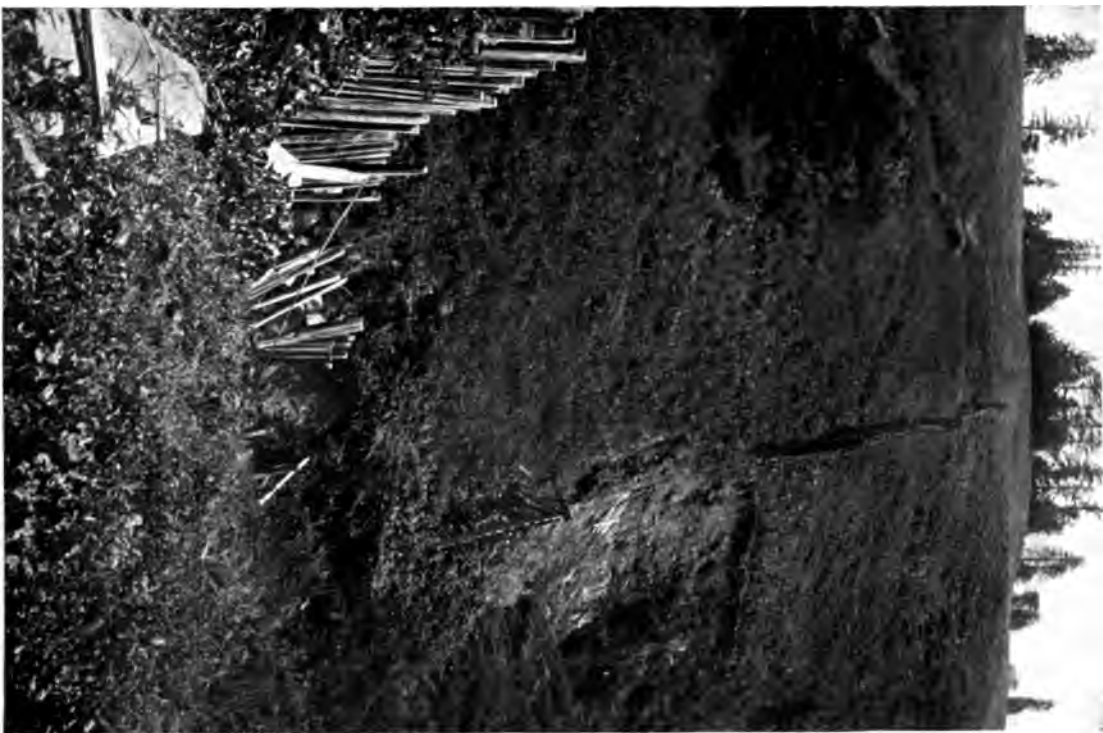
B. Dislocation of fence near Fort Ross. J. N. I.

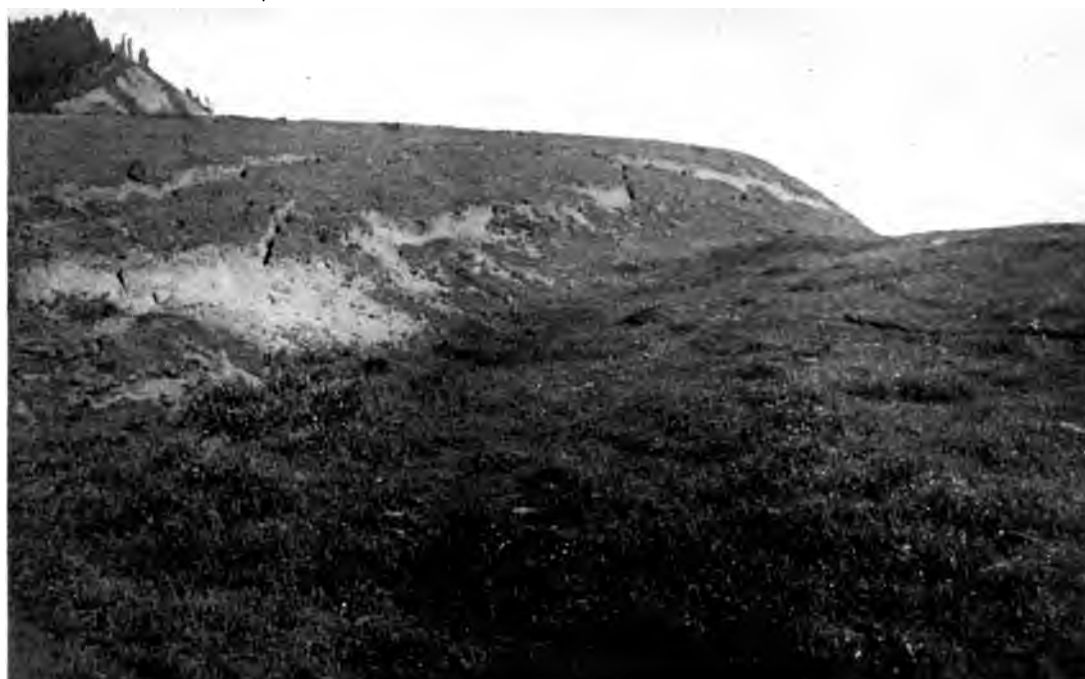
A. Accentuation of old scarp by new fault 1.5 miles north of Fort Ross. J. N. L.

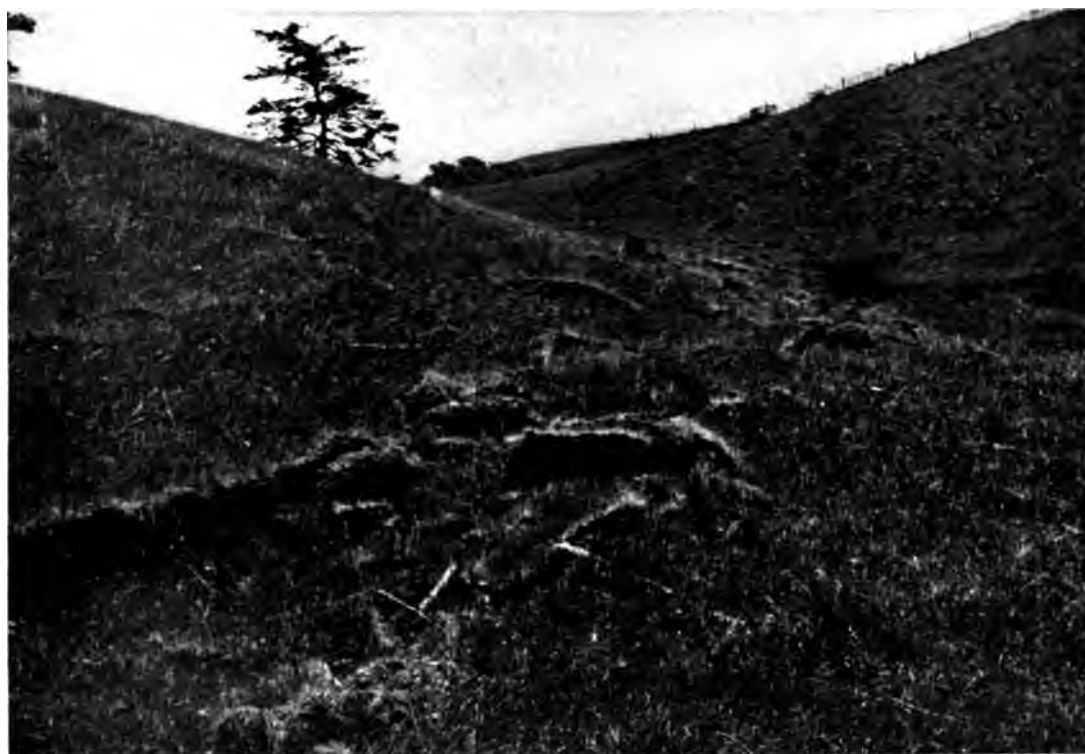
B. Fault-trace on grass-covered slope near Fort Ross. B. L. H.

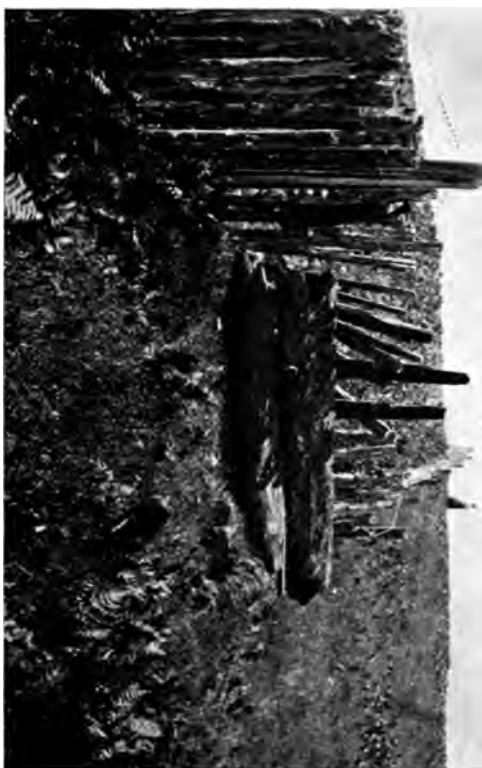
A. Offset of 8 feet on fence a mile east of Fort Ross. R. S. H.

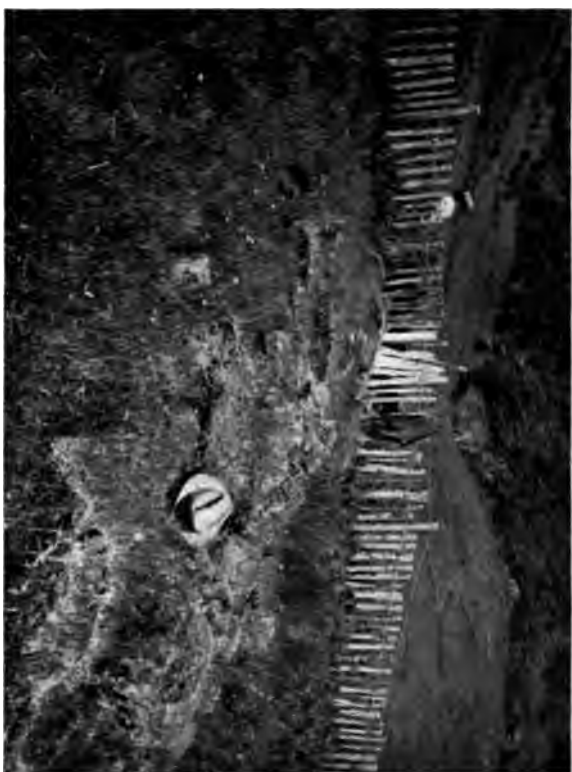
B. Fault-trace and dislocated fence near Fort Ross. R. S. H.

uted over a zone 415 feet in width. Another fence farther southeast on Doda's ranch, having a bearing of N.  $36^{\circ}$  E., was offset on the fault-line 15 feet; the southwest side, as usual, having moved relatively to the northwest. This fence is shown in plate 34B. One of the most interesting effects of the displacement due to the fault is that seen where the latter intersects a small stream at Doda's ranch-house. The stream flows transversely to the line of the fault, and has a trench across the terrace about 5 feet deep. On the lower or southwest side of the fault, the stream trench has been moved northwesterly about 12 feet, so as to bring a fault-scarp across the entire width of the upper part of the trench and impound its waters in the form of a pool. The result is shown in plate 37A and also on Mr. Matthes' map of the Rift at this place (map No. 3). The impounding of the waters on the line of the fault is interesting evidence of the absence of any open crack.

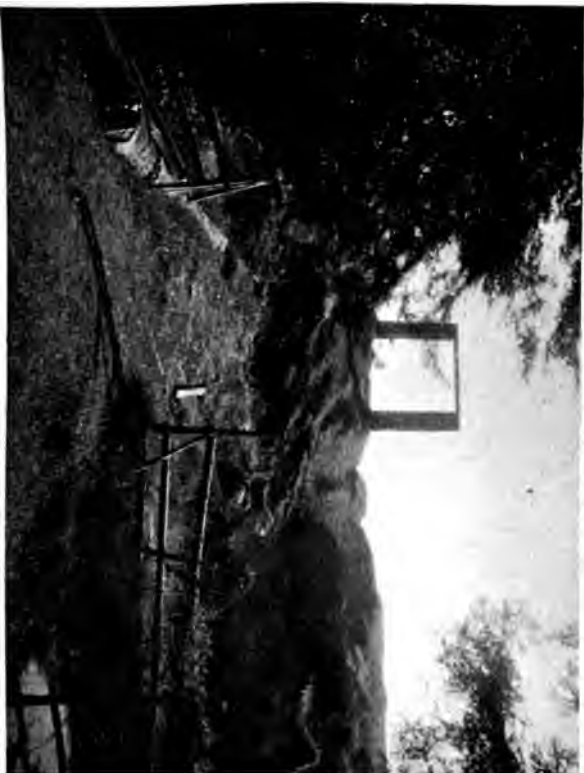
C. Roadway offset 12 feet. New fault-scarp 3 feet high, facing northeast. Above Fort Ross. F. E. M.
